CALSPAN ON-SITE AIR BAG DEPLOYMENT INVESTIGATION
CALSPAN CASE NO. 92-12
VEHICLE - POLICE 1991 FORD LTD CROWN VICTORIA
LOCATION - [REDACTED] CA
ACCIDENT DATE - [REDACTED] 1992

14. Sponsoring Agency Code	
15. Supplementary Notes On-site investigation of a single vehicle roadside departure crash that involved a police 1991 Ford LTD Crown Victoria. The driver sustained a minor (AIS-1) burn of the left fingers from contact with the inflation module.

17. Key Words Roadside departure crash Right side impacts Air bag deployment Inflator temperatures of 300°C (578°F) Thermal burns of driver's left hand, AIS-1		18. Distribution Statement General Public

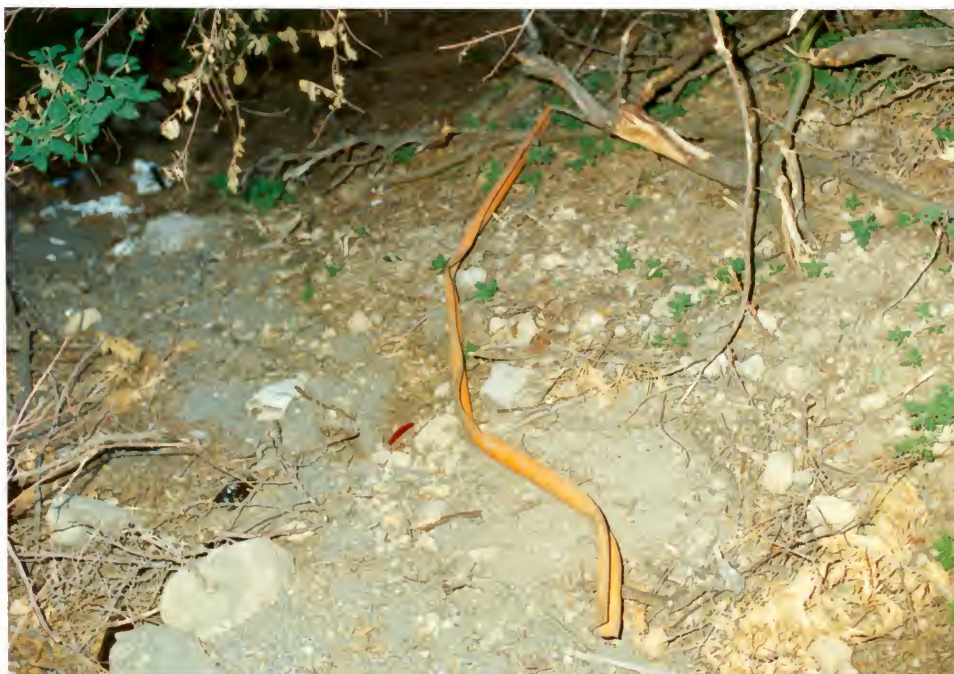
The right front fender of the Crown Victoria impacted and dislodged a steel delineator post from the cinder and earth south shoulder. The impact resulted in minor damage to the vehicle and produced an impact force of 2 o'clock. Again, the minor severity impact with the delineator did not alter the trajectory of the vehicle.

Struck And Displaced Delineator Post.

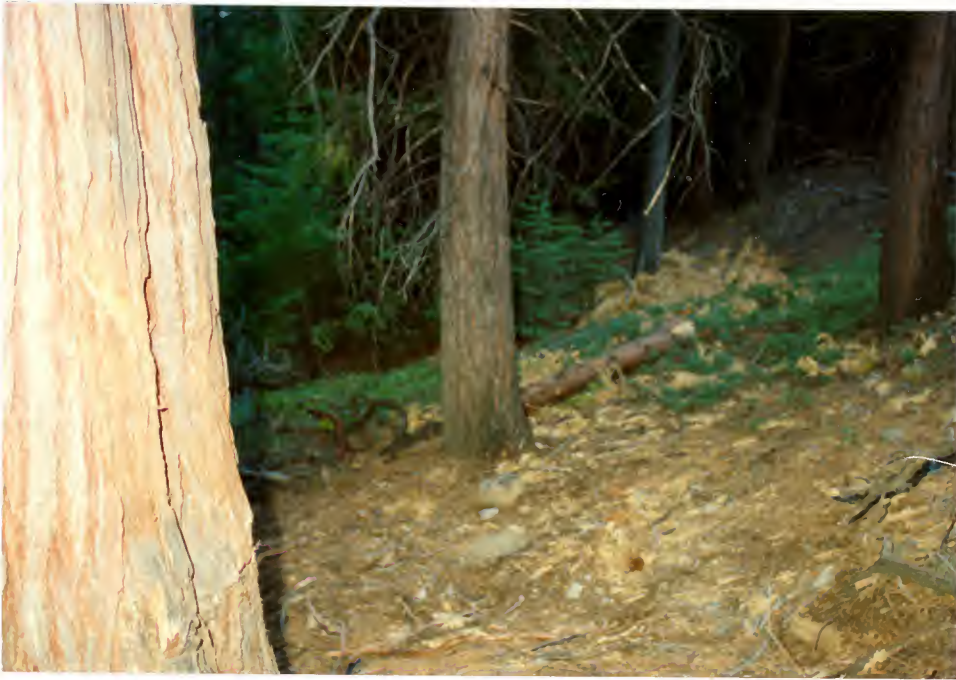
The right passenger compartment area of the vehicle subsequently impacted a 25.4cm (10") diameter cedar tree that was located 2.4m (8') east of the struck 20.3cm (8") diameter tree. At impact with the tree, the vehicle was pitched slightly to its right and struck the tree with its right roof, siderail, door and sill areas. Maximum crush was 83.8cm (33") located on the siderail at the B-pillar area. Again, the vehicle fractured the 25.4cm (10") diameter tree 1.9m (6'3") above the ground and deflected the remaining stump to the east as it overrode the tree trunk. The force of the impact hurled the upper portion of the tree into a wooded area where it came to rest 6.1m (20') to the east of its struck location.

Mid Section Of The Struck
And Fractured 25.4cm (10") Diameter Tree.

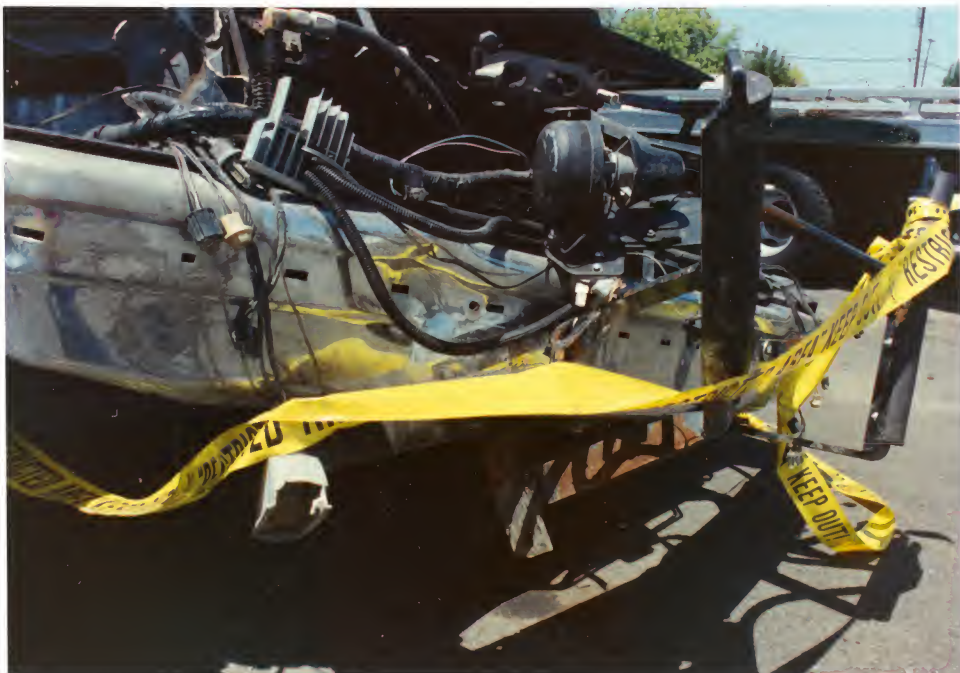
Tree Impact Damage To The Right Bumper Push Bar.

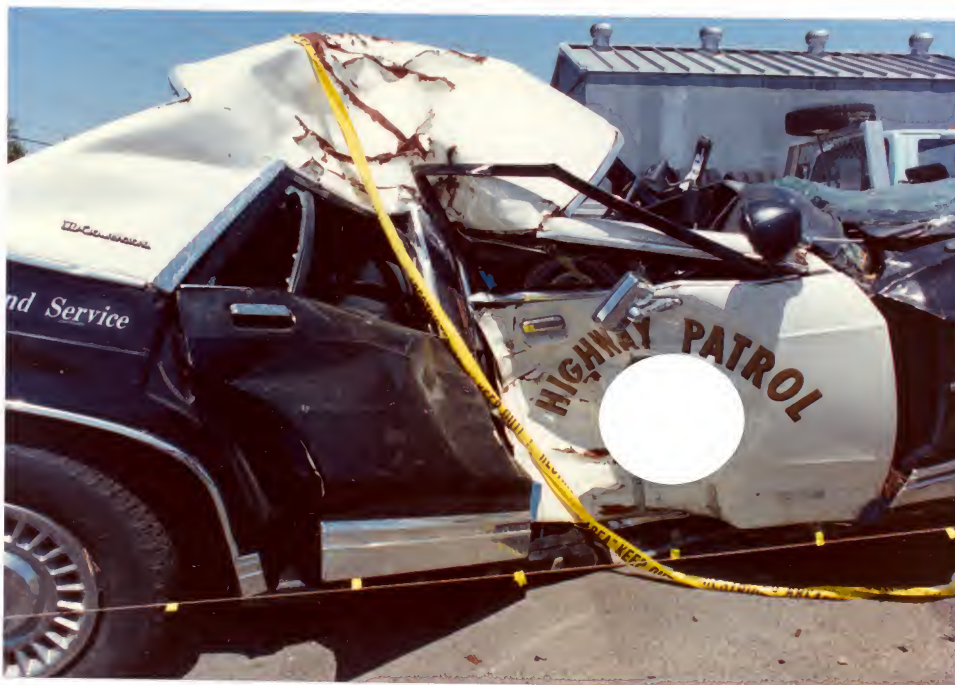
The interior of the Ford Crown Victoria was severely damaged as a result of exterior deformation and driver contact. The right passenger side impact with the 50.8cm (10") diameter tree produced severe intrusion of the right side components. Maximum intrusion involved 83.8cm (33") of lateral displacement of the right roof side rail, the roof and the upper B-pillar at the side rail juncture. Due to the severe lateral displacement of the side rail, the roof was crushed to a near vertical surface on the interior of the vehicle. The mid right B-pillar and right front door panel intruded into the center front occupant space, resulting in a lateral displacement of 76.7cm (30.2").

Primary Impact Damage To The Right Passenger Compartment Area.

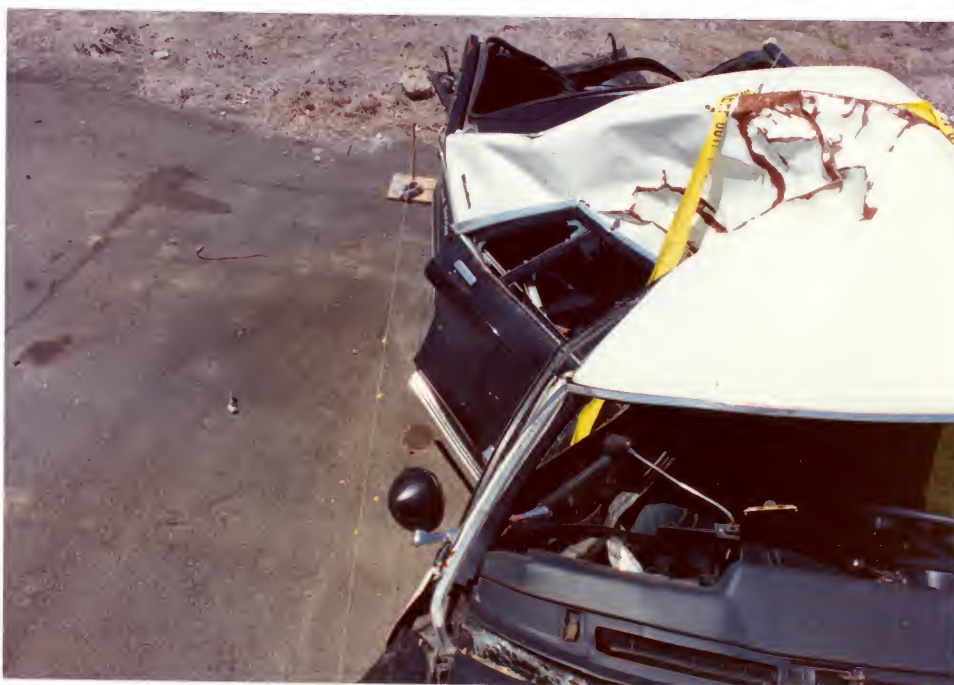
Overhead View Showing The Extent Of Crush.

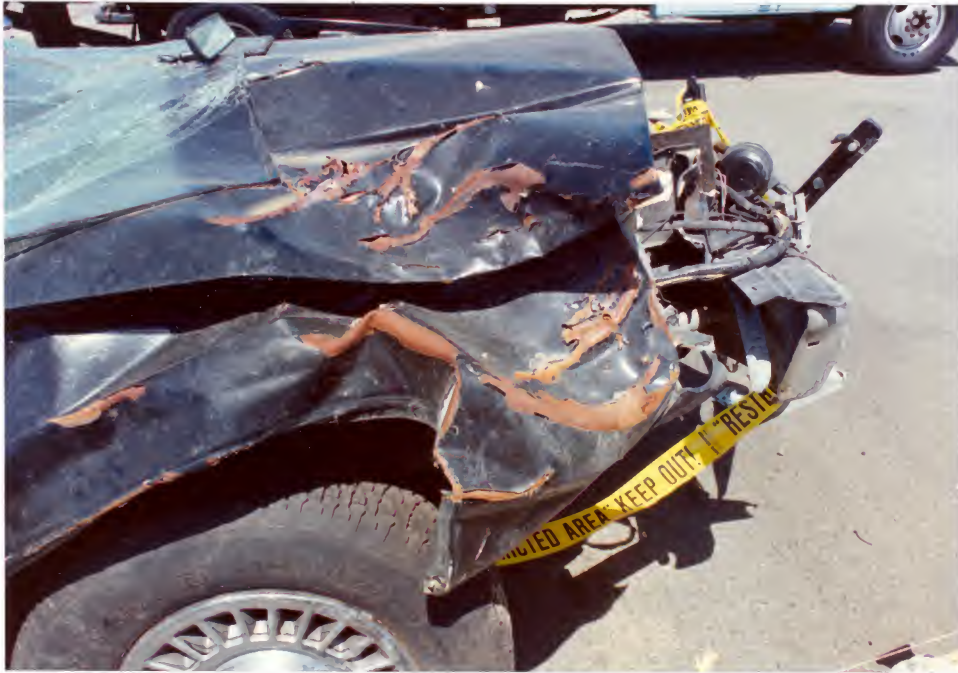
Due to the slope of the embankment, the broadside trajectory of the vehicle, and vehicle contact with the ground, the Crown Victoria began to pitch to its right. The upper surface of the right front fender impacted a 20.3cm (8") diameter cedar tree that was located 9.1m (30') outboard of the roadedge. The tree impact damage began on the fender at bumper level and extended vertically onto the top of the fender and hood, indicating a non-horizontal (00-LFMN-3)) impact force. Direct contact damage began 40.6cm (16") forward of the axle position and extended 20.3cm (8") forward to the leading edge of the fender. The vehicle subsequently impacted a small diameter tree with the right front fender area. The damage was located 16.5-30.5cm (6.5-12") forward of the referenced axle position and involved 7.6cm (3") of crush on the lip of the wheel opening. The

Tree Impact Damage To The Right Front Fender Area.

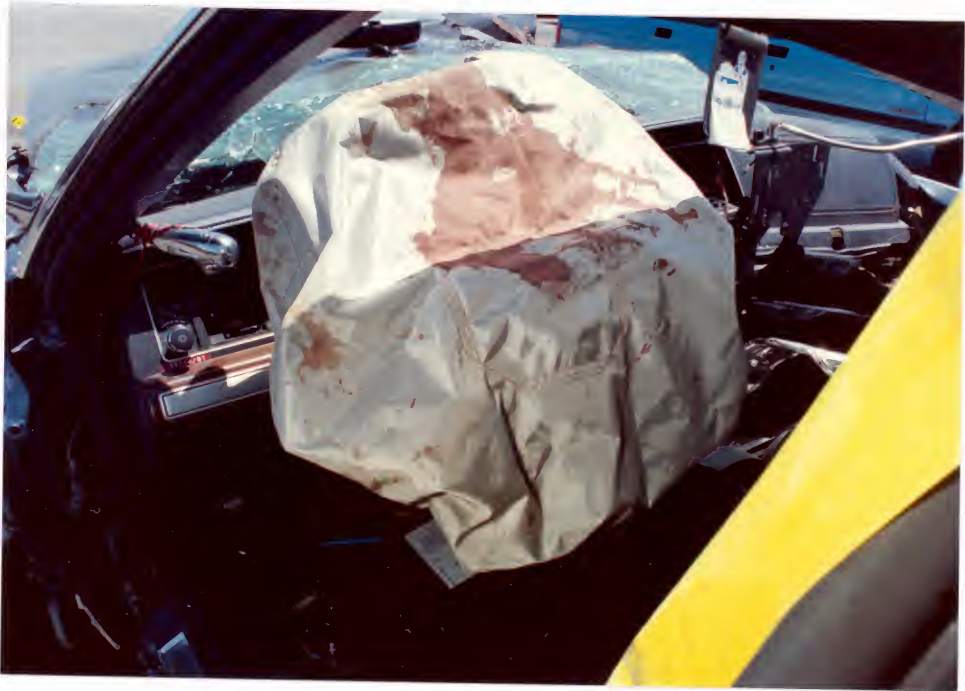
The upper center portion of the air bag was heavily stained by blood from the driver as he came to rest slumped against the deflated air bag. His left hand came to rest under the upper module flap and was pressed against the air bag and the inflator housing. As a result of contact with the hot inflator housing, the heat was transmitted through the bag which subsequently burned the dorsal surface of his left middle, ring, and fifth fingers. The contact also melted the face of the bag at the 9:30 o'clock position. The melted area measured 1.3 x 7.0cm (0.5 x 2.75") and was horizontally located 8.3-9.5cm (3.25-3.75") above the mid point of the bag and 19.1-26cm (7.5-10.25") left of the vertical centerline. The melted area was also located 4.4-10.2cm (1.75-4.0") inboard and toward the driver from the peripheral seam. Upon magnification of the melted area, tissue fragments and blood were found fused to the nylon fabric.

Overall View Of The Deployed Air Bag.

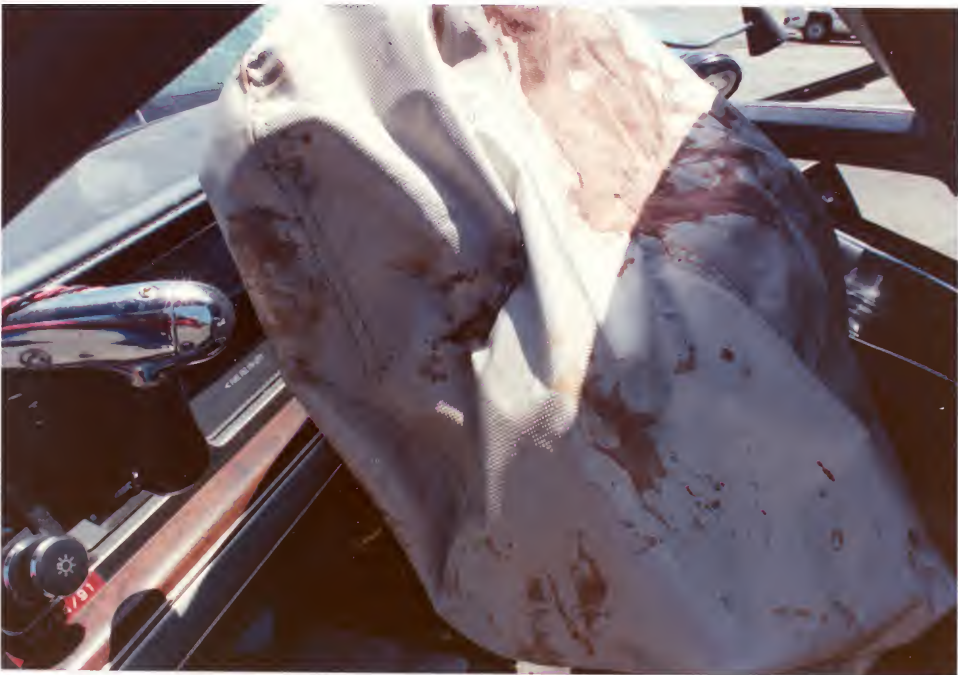
Melted Area Of The Deployed Air Bag.

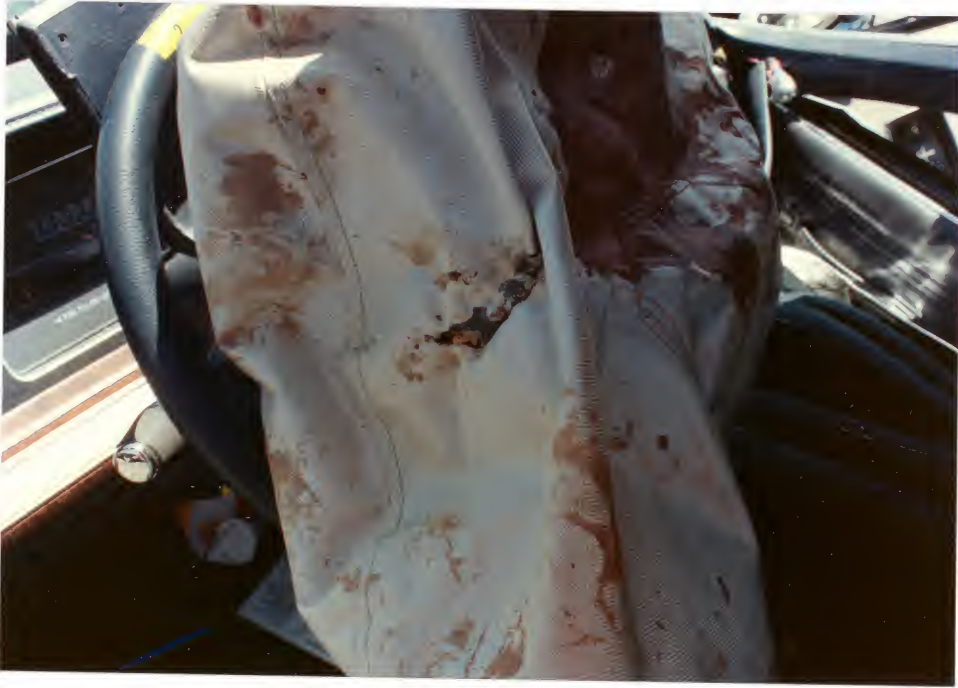
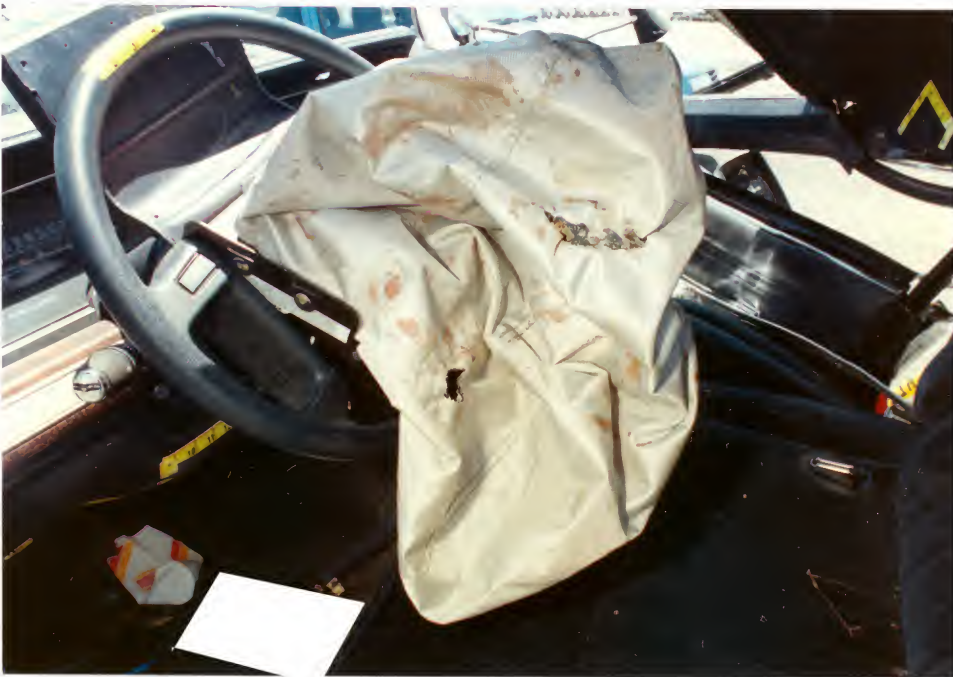
Additional Views Of The Melted Area Of The Air Bag.

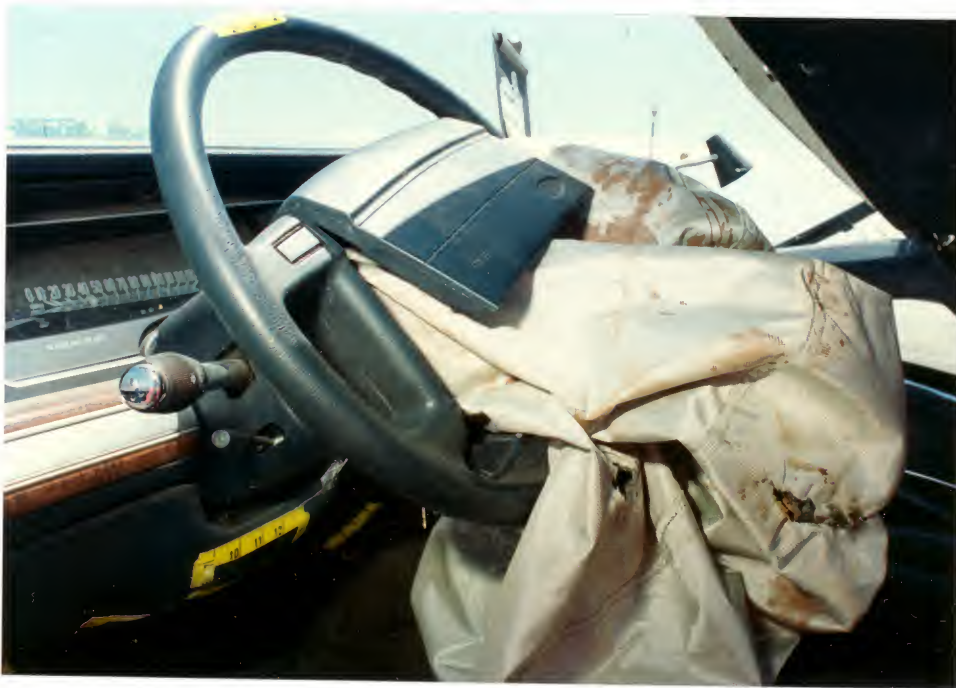
Upper Air Bag Module Flap.

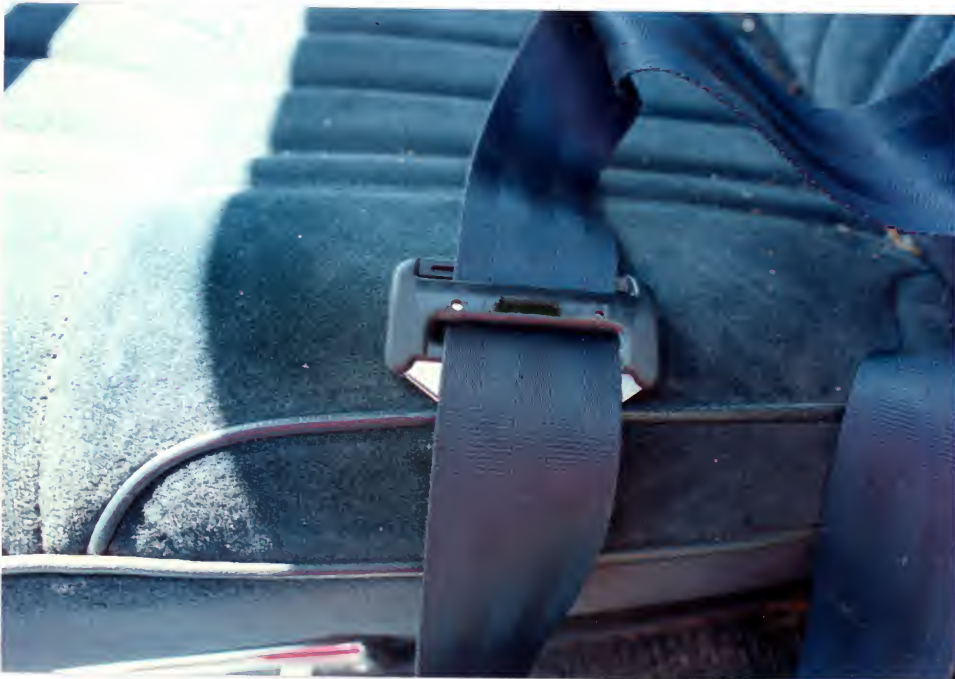
Belt Loading Abrasions To The Plastic Coating On The Latchplate.

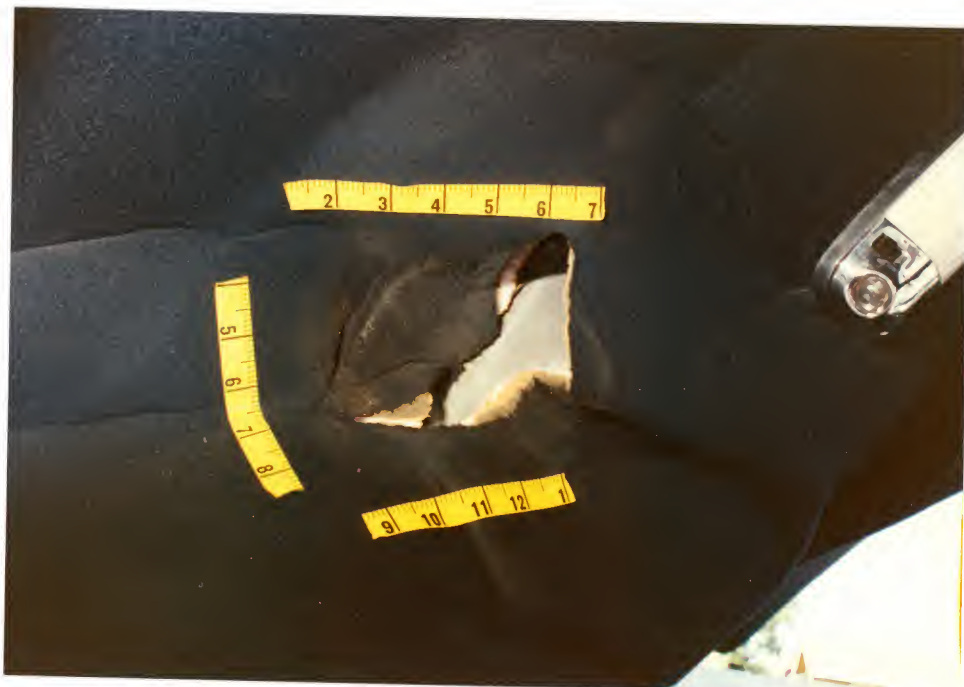
The driver's head and facial areas impacted the intruding vertical surface of the roof. The 11.4cm (4.5") diameter contact cracked the backer panel to the headliner and bowed the roof panel outward .6cm (.25"). The contact point was located 38-51cm (15-20") rearward of the A-pillar and 22-34cm (8.8-13.3") above the roof side rail. His right forearm impacted the right siderail 20-29cm (8-11.5") rearward of the A-pillar, depositing tissue transfers on the fabric covering. The driver's thoracic area contacted the B-pillar; however, no

Head Contact To Headliner And Roof.

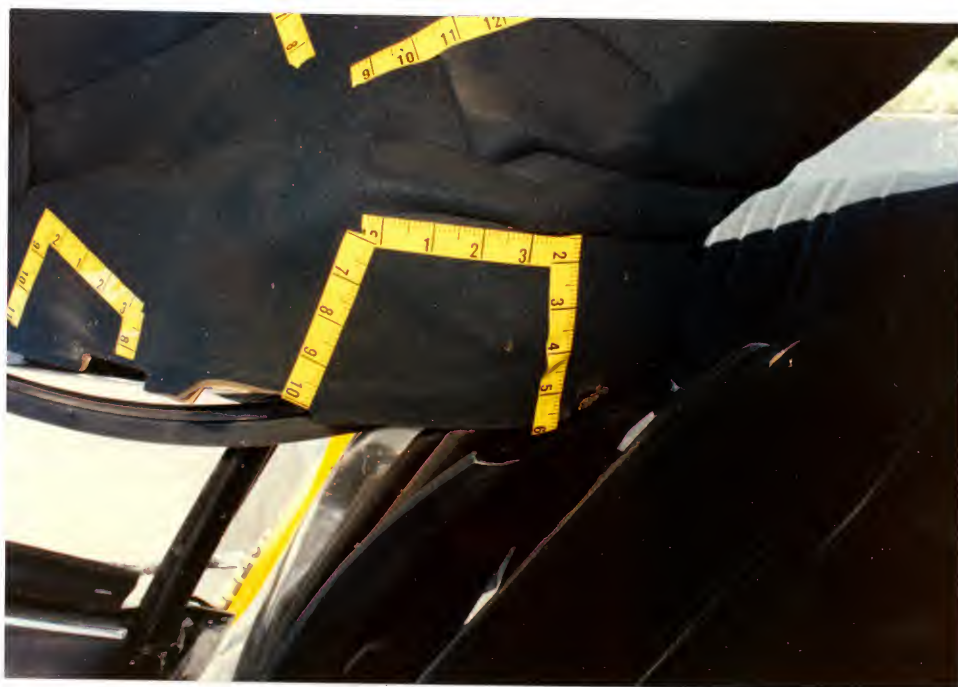
immediately forward of the right B-pillar. The contact resulted in a fracture of his right clavicle (AIS-2). His right forearm impacted the right roof side rail 20.3-29.2cm (8-11.5") rearward of the right upper A-pillar. The contact was evidenced by tissue transfers on the headliner fabric that covered the side rail area. As a result of the side rail contact, the driver sustained a comminuted fracture of the right radial head (AIS-3) and a fracture of the right proximal ulna (AIS-2).

Right Shoulder And Arm Contacts To The Roof Side Rail.

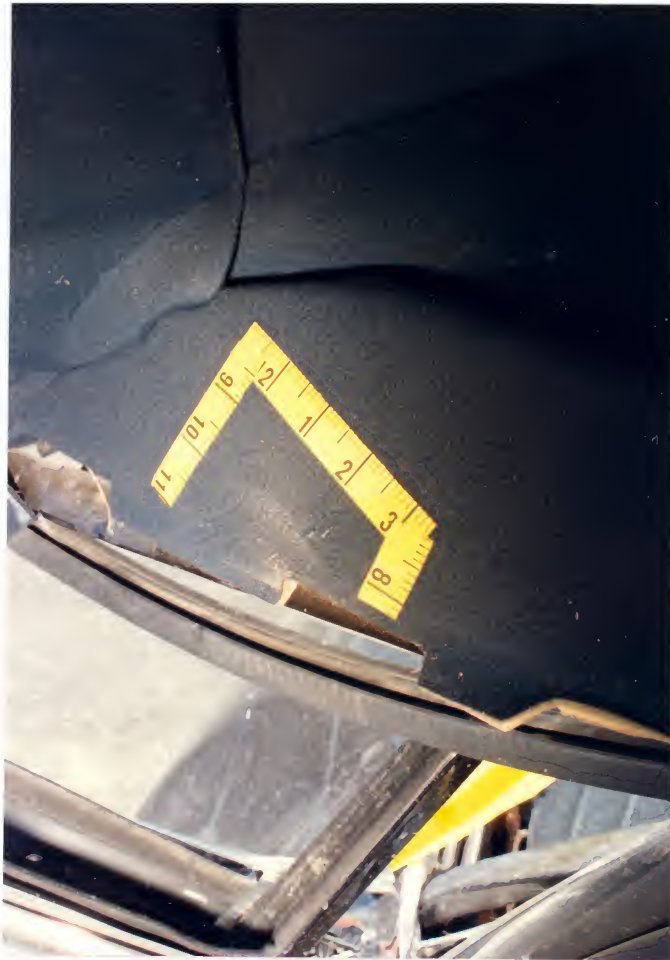
The driver's right forearm flailed upward with respect to his seated position and impacted the intruding right roof siderail 20.3-29.2cm (8-11.5") rearward of the upper A-pillar. Tissue transfers evidenced the contact which resulted in a comminuted fracture of the right radial head and a fracture of the right proximal ulna. The driver's right shoulder subsequently impacted and scuffed the intruding right roof side rail immediately forward of the B-pillar. The contact fractured the mid-portion of the driver's right clavicle. His right lateral chest area impacted the intruding right upper B-pillar and possibly the struck tree as the vehicle crushed to maximum engagement. Although no contact evidence was visible on the vinyl jacket covering the B-pillar, the driver sustained fractured right ribs 2-9 with flail chest, right pneumothorax, and a right pulmonary contusion.

Apparent Tissue Transfer From Right Forearm Contact
To Roof Side Rail.

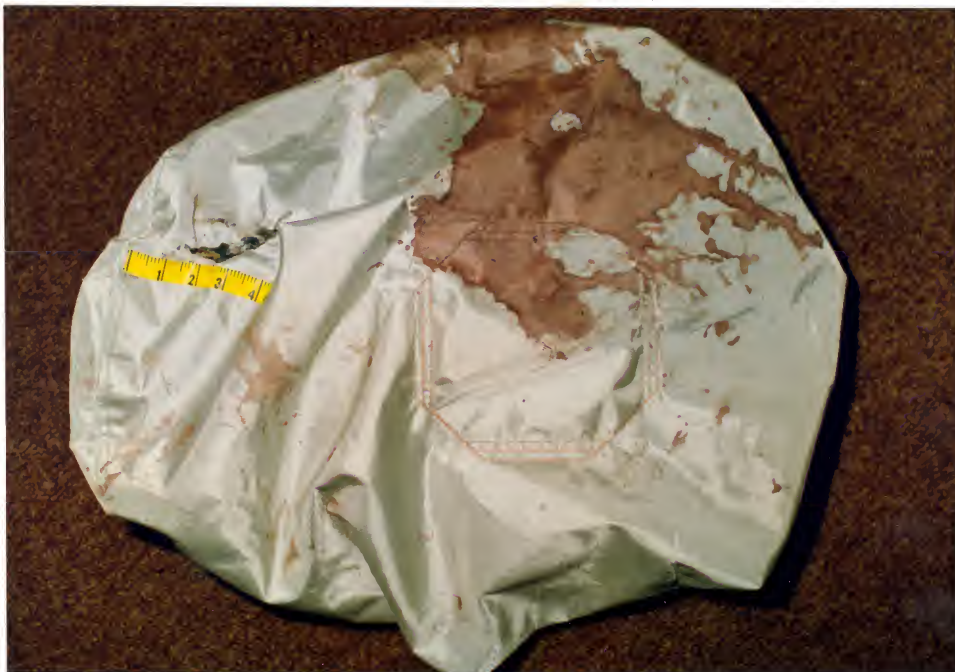
Location Of Burn With Respect To The Center Of The Air Bag.

BURN ON FACE OF BAG
1.75-4.0" INBOARD OF
PERIPHERAL SEAM

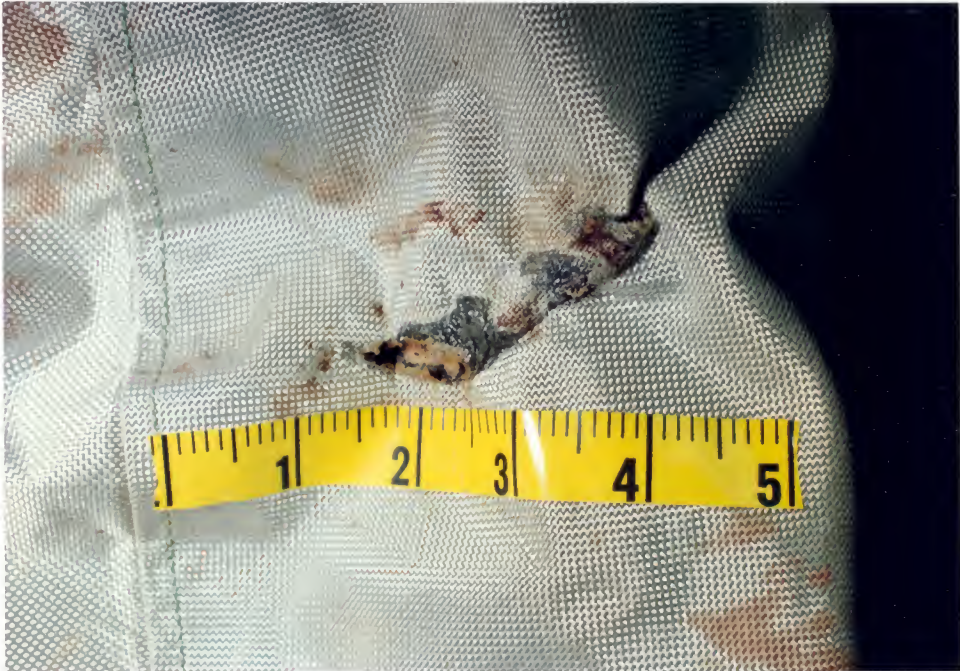
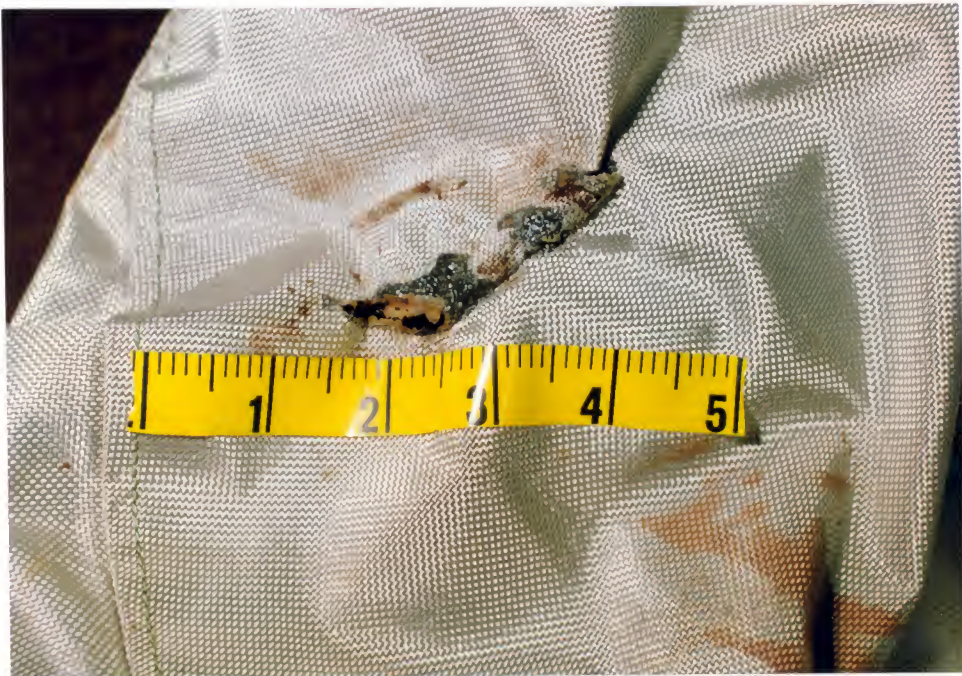
fingers, which resulted in full thickness thermal burns with loss of the extensor tendons and devascularization of part of the bones within the digits.

Closeup Views Of The Burned Area.

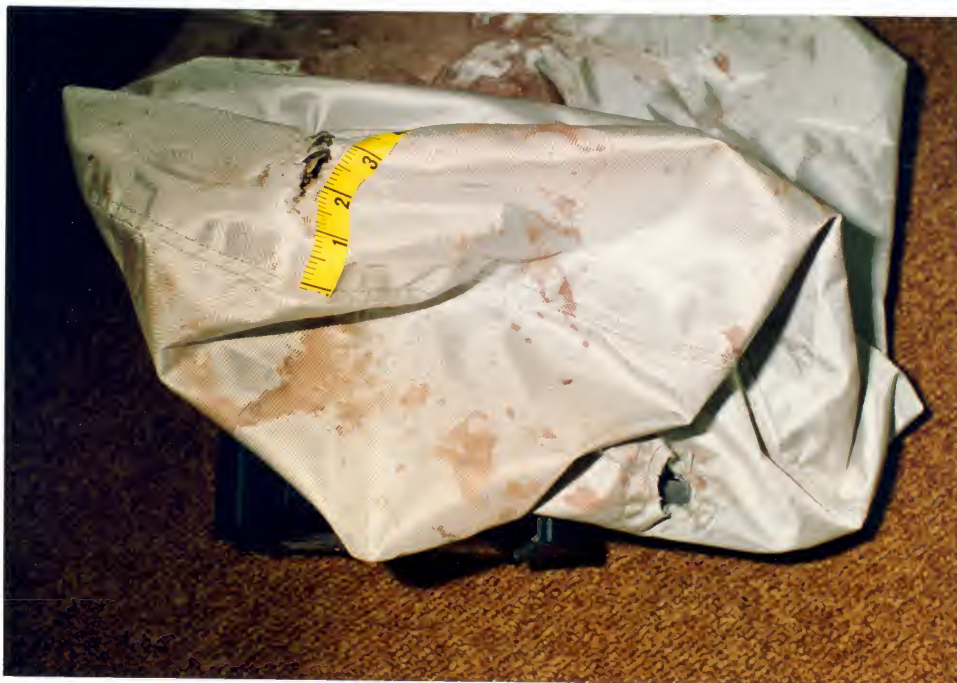
Location Of Burn With Respect To The Peripheral Seam.

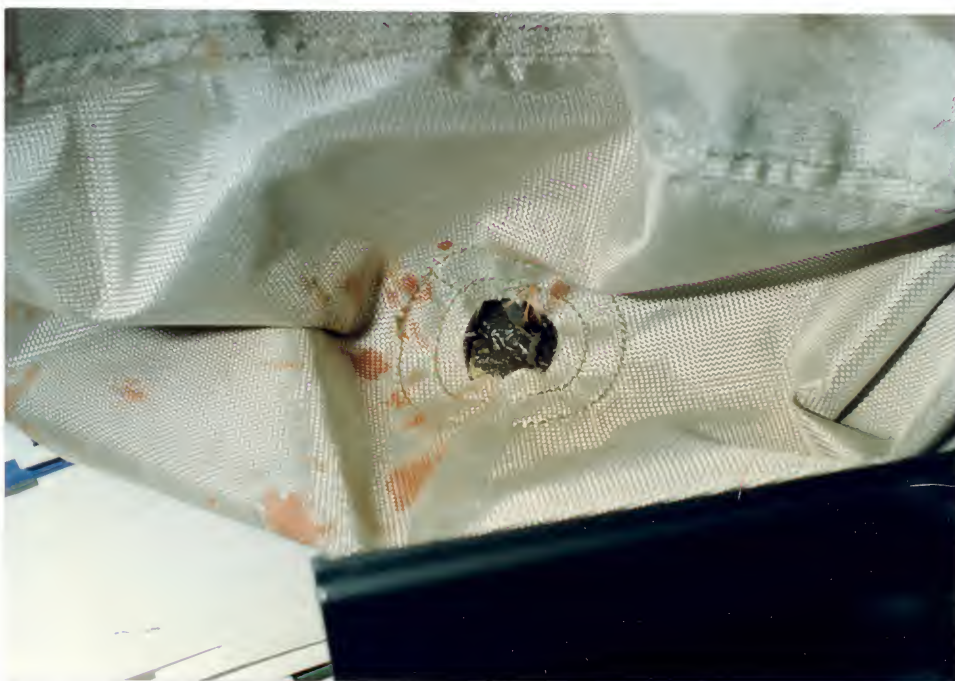
View Of A Melted Internal Tether Strap
Through The Left Venting Port.

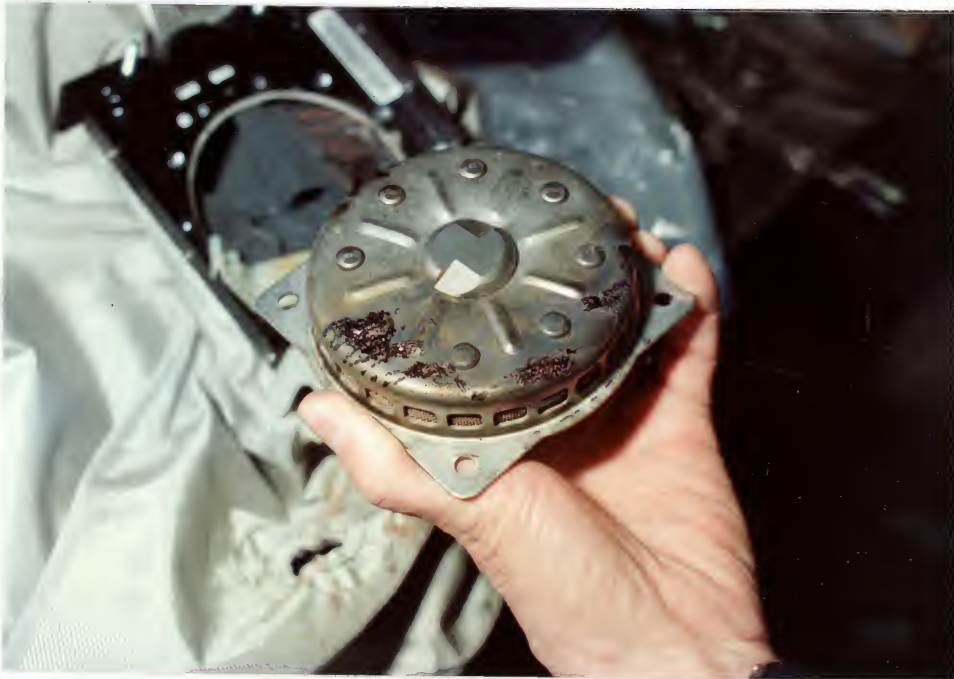
During our on-site investigation of this crash, a representative from TRW (manufacturer of the air bag module) was present to inspect and dismantle the module assembly. During his discussion of the deployment process, he stated that the air bag material, which consists of woven nylon with a neoprene liner, will not support a flame; however, it does have a melting point of 154-177° C. (310-350° F.). The inflation module, which is primarily stainless steel, reaches deployment temperatures of 300° C. (578° F.) and cools slowly due to its isolated, non-vented location.

Melted Bag Material On The Face Of The Inflator.

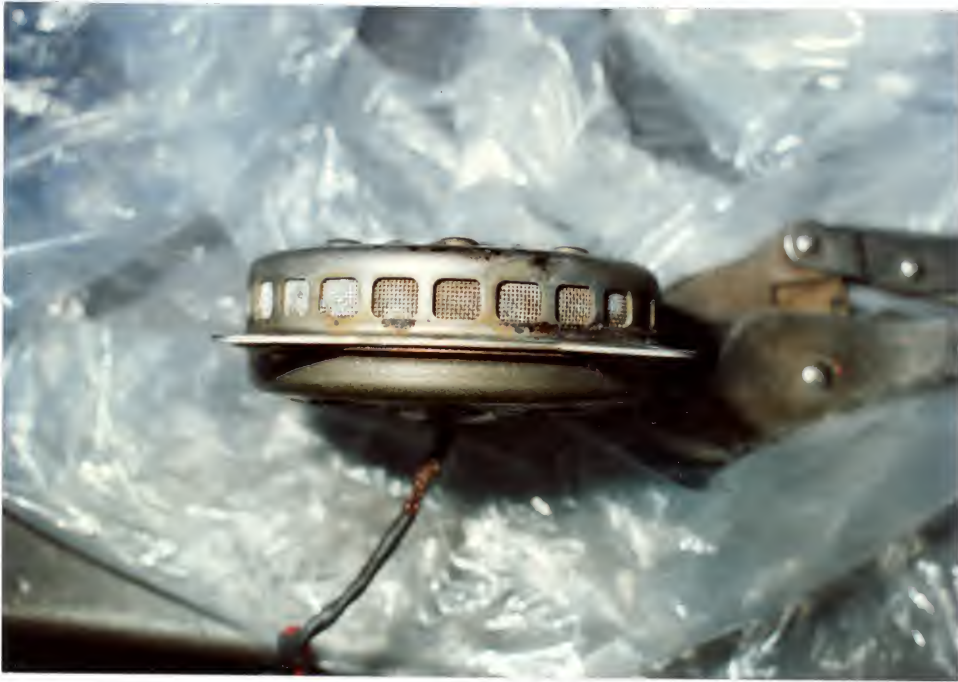
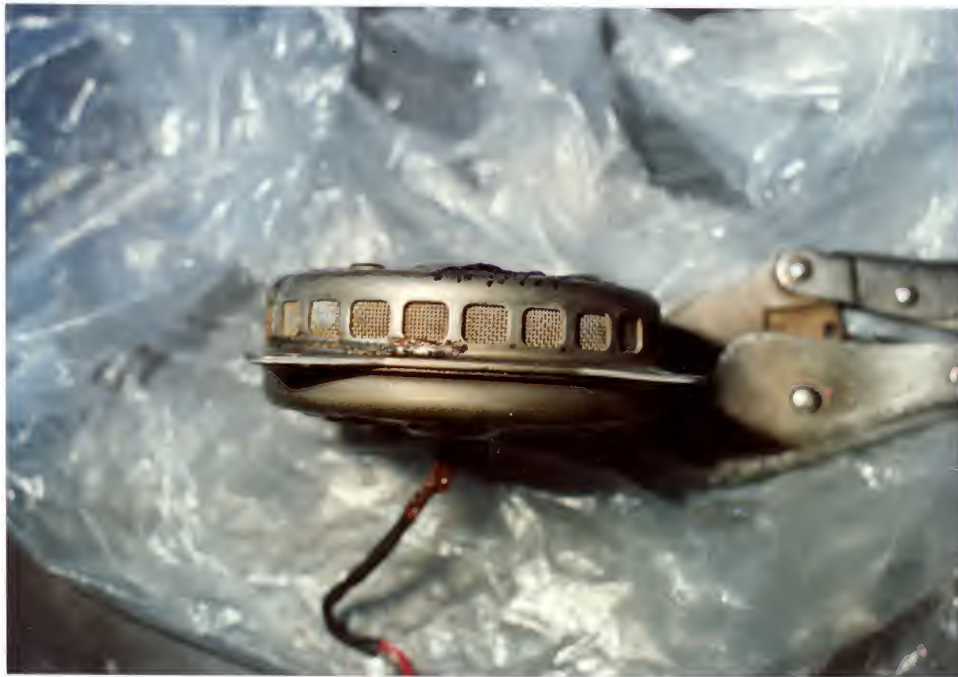
An external inspection of the inflator assembly did not yield evidence of filtering screen burnthrough or separation of the initiator assembly. The assembly was intact and appeared to have performed as designed. Due to the nature of the driver's burn injury and the melting of the bag, it was decided that disassembly of the inflator was not necessary. The module assembly was identified by the following alpha/numerical sequences: [REDACTED] AND [REDACTED].

Views Of The Radial Inflation Ports
Of The Inflator Assembly.

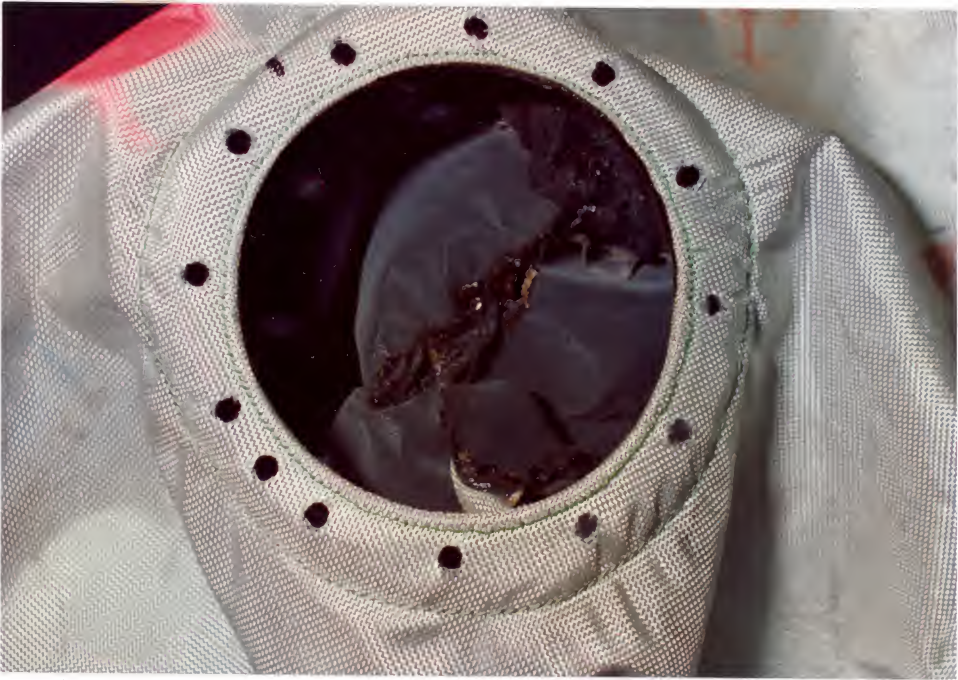
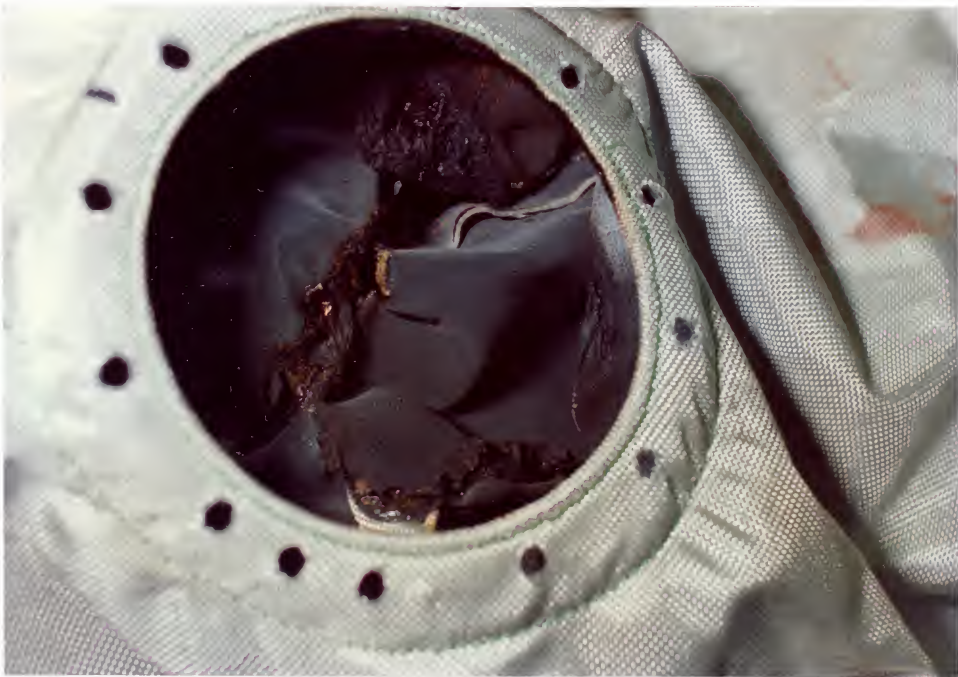
Internal Views Of The Melted Areas Of The Air Bag.
